# Manhole Inspection Summary

Manhole # S37WW\_045MH

Insp Date: **1/4/07 9:40 AM**

**Location** Address: **3100 BRENTWOOD AVE**

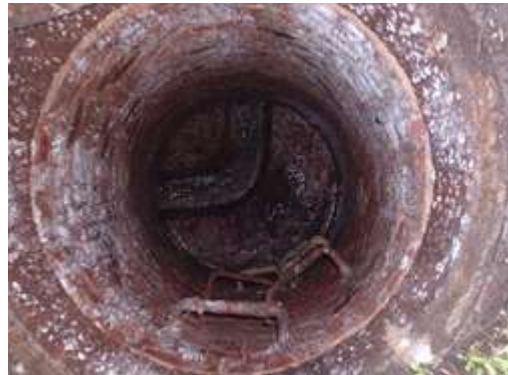
Top View

Corroded steps. Evidence of surcharge - Bench debris.

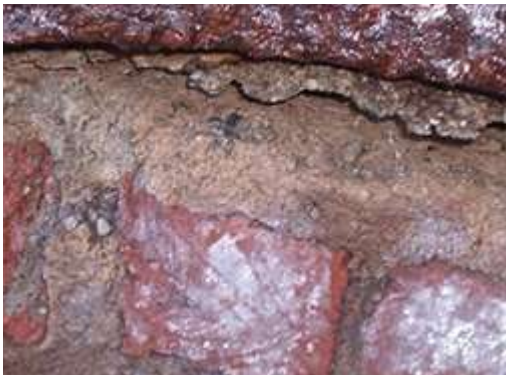
Defect

Adjustment deterioration and infiltration.

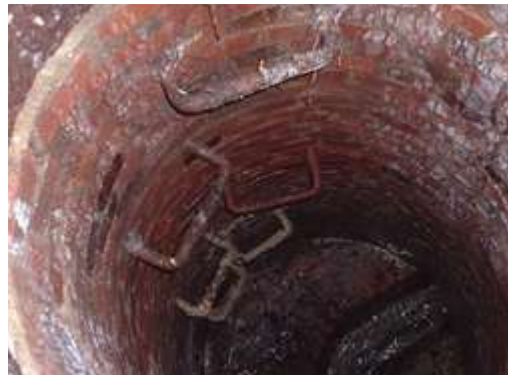
Defect

Adjustment and Barrel infiltration.  
Corroded steps.

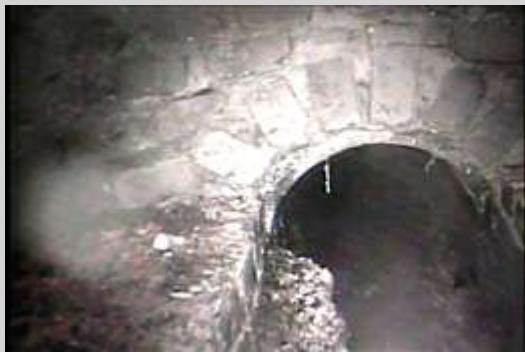
### 12 in. Circular Gravity Sewer Pipe Out @ 12 O'Clock

Comments **The O12 pipe picture shows Heavy grease deposits in the Channel.**

Deposits: ☐ None ☐ Mud ☐ Sludge ☐ Debris ☒ Grease

Silt Depth: **0** (in.) Deposits Extent: **Medium**

Infiltration: **Evidence** Pipe Seal Cond: **Unknown**

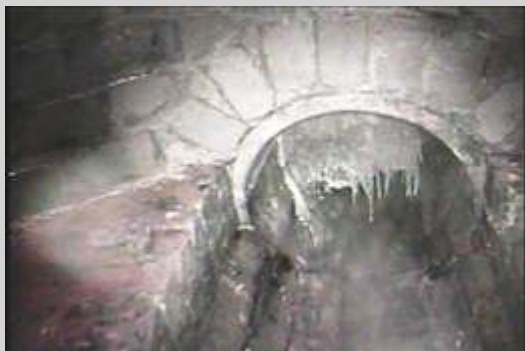
### 12 in. Circular Gravity Sewer Pipe In @ 9 O'Clock

Infiltration: **Evidence** Pipe Seal Cond: **Unknown**
